**Flood Control Project Maintenance
Levee Inspections**
LMA District Cover Sheet
Spring 2020 Levee Inspection Results

Sacramento River West Side Levee District

Spring 2020 Levee Inspection Results

Waterway			Bank	Unit Miles
Unit No. 01 Sacramento River			Right	49.64
	Spring (March - May)	Summer (June - August)	(September - November) Fall	Winter (December - February)
Unit Maintenance Rating (Fall Only)				
Date of Inspection	3/24/2020 - 3/24/2020			
DWR Inspector	Zach Jojola			
Accompanied By	Gary Marler RD0108

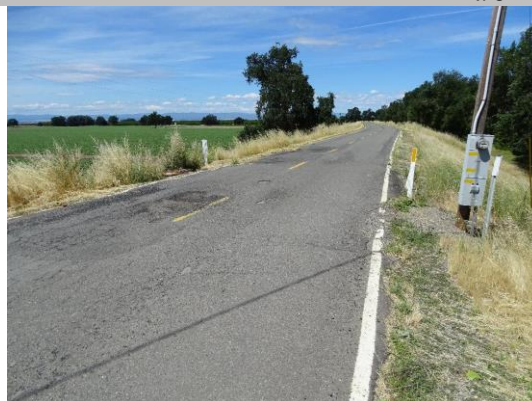
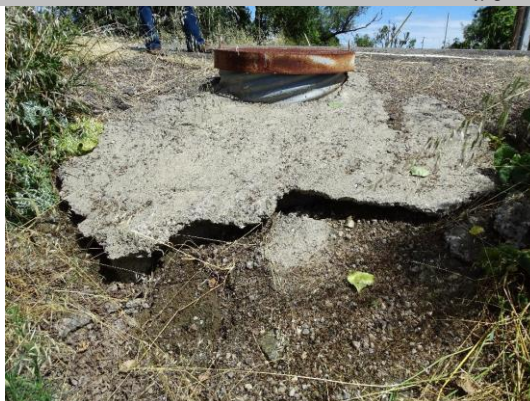
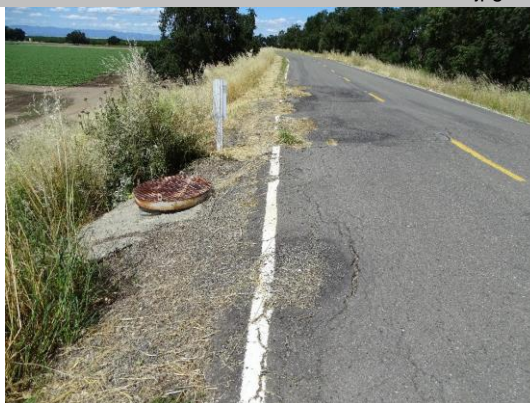
UCIP Comments: 05/23/2019 No visible changes to crossing status since last inspection. Pipe outlet is disconnected at LS toe which means that pipe not in use. (O.Yakimov - DWR UCIP)10/15/2018 Multiple cracks and points of depression on levee crown pavement (Moon Bend Rd). Sink hole on LS shoulder next to CMP riser. Voids around lower part of CMP riser concrete pad on LS shoulder. Condition of this crossing has worsen since last inspection. Recommend internal pipe inspection to determine pipe integrity through levee. (O.Yakimov - DWR)09/23/2016 - A second pipe is visible adjacent to the intake pipe. According to the permit drawings, this pipe is an access pipe for a submersible pump used to clean the fish screen by backwashing. hole on LS shoulder of the levee and Moon Bend Rd. has been patched. No additional road damage is visible. (T. Hatch/UCIP) 09/01/2016 no visible changes from previous inspection. - (T. Hatch/UCIP)

10/09/2015 Possible sink hole along alignment 10-feet LS of siphon breaker on LS slope. Recent road repair along the approximate pipe alignment suggests that levee slumping is related to pipe. It is recommended that further investigation e.g. video inspection or other internal method may help determine if the issue is due to pipe or due to levee settlement in vicinity of the pipe. (T. Hatch/UCIP)

Levee crown at crossing

CMP riser on LS shoulder

Multiple cracks and poits of depression on levee crown

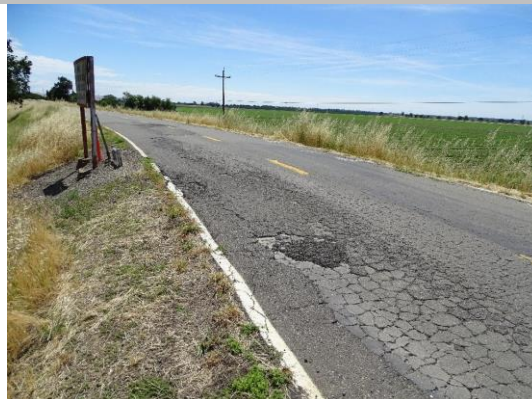
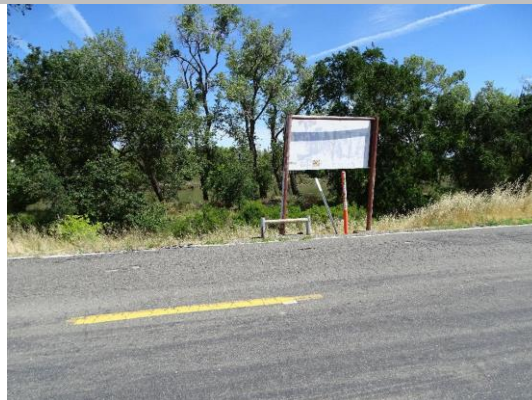
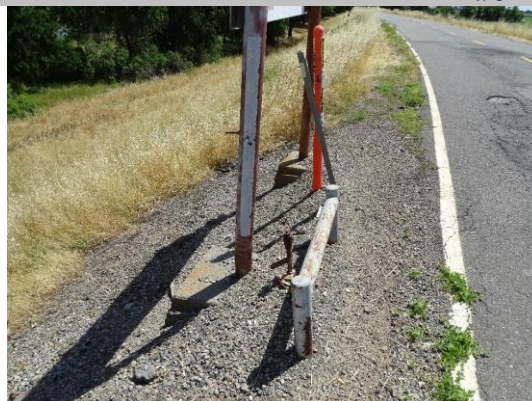
Comment Code						
Inspector Comment						
DS_ID:20297 FS_ID:54228 EP_NO: 7343 Repair Type: Non-Urgent Crossing Status: Found UCIP Comments: 05/23/2019 Record updated from No Action Needed to Non-Urgent. No records available to determine status of line. (O.Yakimov - DWR UCIP) FIELD_STRUCT_DESC: 8-inch steel gas pipeline through the levee, 3 feet below the crown. Cutoff wall, installed in 1971. Signage and shutoff valve on the landside (LS) toe. Large sign and vent on the waterside (WS) shoulder. Continues across channel. (8-inch gas line across channel and both levees is authorized under permit No. 7343, 1971 - PG&E). [Additional Reference(s): DWR Levee Log, 2006, HLM 47.04]. FS Date: 5/23/2019 8:19:52 AM

Levee crown at crossing

Gasline marker and air valve on WS shoulder

Vent on WS shoulder

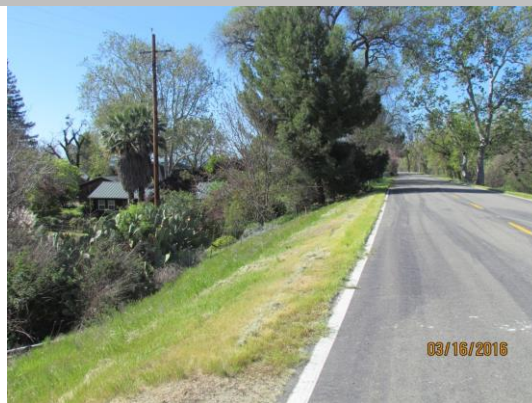
LM Start	47.01	Rating **	M	Issue No.	54
LM End	47.14	Issue Type +	En	Location *	LS
Category	Earthen Levee			GPS Latitude/Longitude	
				Start	End
Item	Vegetation			39.188544 °	39.189733 °
				-121.979272 °	-121.981232 °
DWR ID	DWR_NA0016_01_s_2012_54				
Comment Code					
V6 : Landscaping					
Inspector Comment					
Cactus on slope and toe of levee, landscape continues along roadway with fence and stairs.

View of the landscaping on the landside slope. Spring 2016.

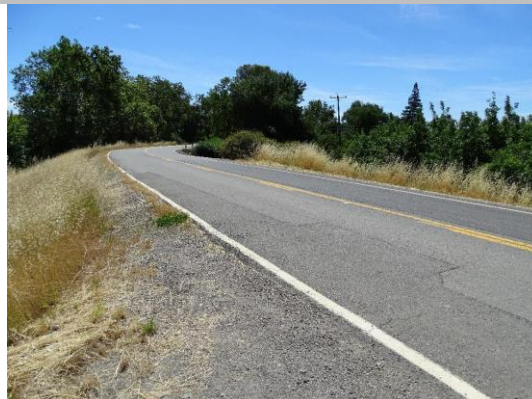
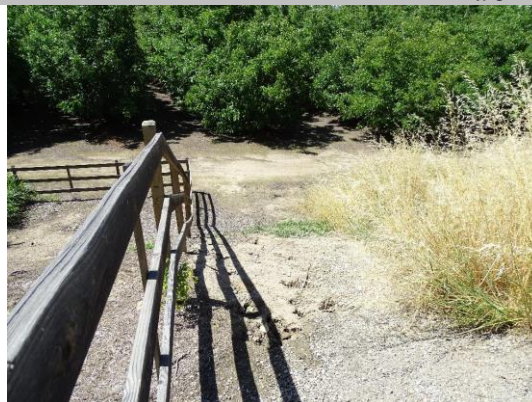
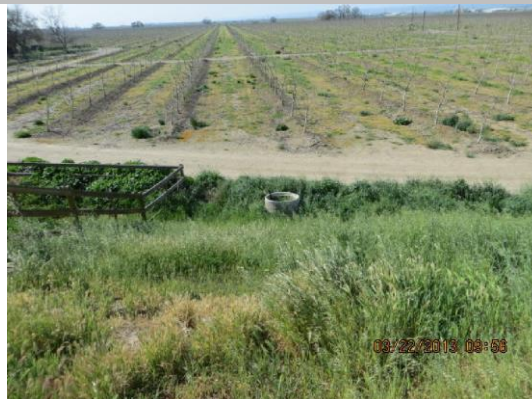
Comment Code					
Inspector Comment					
DS_ID:20298 FS_ID:54230 EP_NO: 9347 Repair Type: Non-Urgent Crossing Status: Indicator Found UCIP Comments: 05/23/2019 Concrete standpipe at LS toe not found. Repeat attempt when vegetation is cleared. (O.Yakimov - DWR UCIP)03/22/2013 Need to verify type of abandonment. FIELD_STRUCT_DESC: 1 of 2: 24-inch irrigation pipe of an unknown material through the levee, 25.5 feet below the crown. 14-inch pipe sleeved through 24-inch pipe. Annular space grouted. Pump inside pump house on the landside (LS). Gate valve inside pump house on the LS. (Automatic Board Order (ABO) issued as Permit No. 9347, 1974 - Floremon Orchards). [Additional Reference(s): DWR Levee Log, 2006. USACE Sacramento O&M Manual 131, May 1960 (HLM 47.71)]. FS Date: 5/23/2019 8:52:46 AM

Levee crown at crossing

View of LS slope where concrete standpipe was located

Possible location for pipe crossing

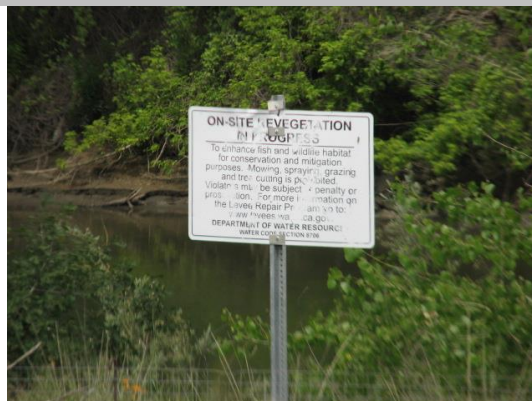
LM Start	47.19	Rating **	A/W	Issue No.	90
LM End	47.62	Issue Type +	Ob	Location *	WS
Category	Earthen Levee			GPS Latitude/Longitude	
				Start	End
Item	Vegetation			39.189930 °	39.193491 °
				-121.982143 °	-121.988184 °
DWR ID	DWR_NA0016_01_s_2014_90				
Comment Code					
V8 : Environmental Requirements.					
Inspector Comment

A revegetation site along the waterside berm. Spring 2014

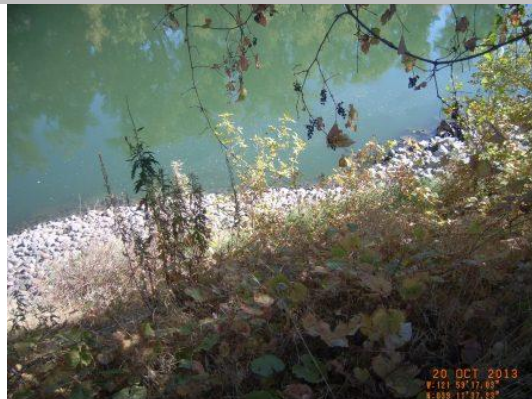
USACE 2013 Photo #1

LM Start	47.62	Rating **	A/W	Issue No.	97
LM End	47.77	Issue Type +	Ma	Location *	WS
Category	Supplemental			GPS Latitude/Longitude	
				Start	End
Item	2017 USACE Erosion Survey			39.193769 °	39.195595 °
				-121.987901 °	-121.988621 °
DWR ID	DWR_NA0016_01_f_2018_97				
Comment Code					
Inspector Comment					
2017 Site ID: SAC 141.5 R					
Status: Eroding					
2017 Field Notes: No observed change.					
Site History: 2010 - Old cobble site starting to unravel at toe. 2011 - Cobbles continue to unravel. 2013 - Site extended downstream to revetment.

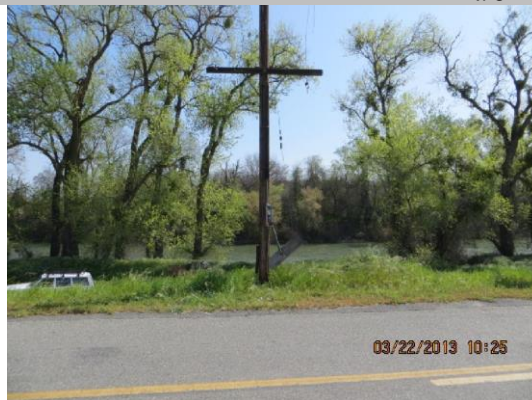
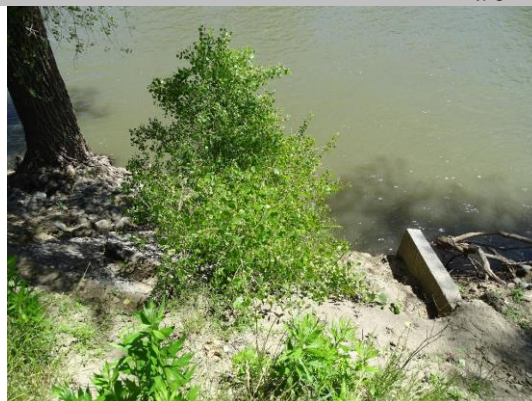
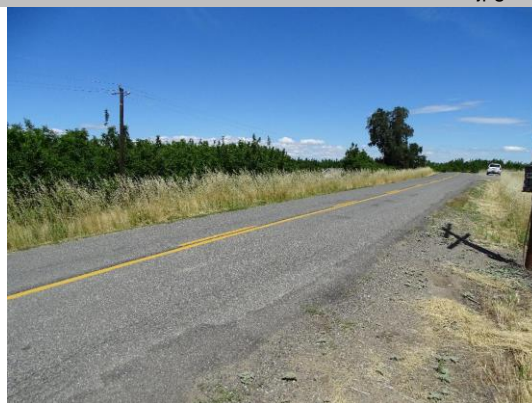
Comment Code					
Inspector Comment					
DS_ID:20309 FS_ID:54231 EP_NO: 9347 Repair Type: Non-Urgent Crossing Status: Indicator Found UCIP Comments: 05/23/2019 Pipe not visible on any of levee sides. Power line is disconnected from junction pole. Electric box at JP is disrupted. Confirm pipe removal. (O.Yakimov - DWR UCIP)03/22/2013 Need to determine type of abandonment. FIELD_STRUCT_DESC: *REMOVED* 2 of 2: 16-inch steel irrigation pipe through the levee, 17.3 feet below the crown. Gate valve on the waterside (WS) end. Pump on the WS bank. Switch box on the WS shoulder. (Automatic Board Order (ABO) issued as Permit No. 9347, 1974 - Floremon Orchards). [Additional Reference(s): DWR Levee Log, 1980. USACE Sacramento O&M Manual 131, May 1960 (HLM 48.23)]. FS Date: 5/23/2019

JP on WS shoulder for removed pump switch house.

Concrete pumphouse debris on WS berm

Levee crown at crossing

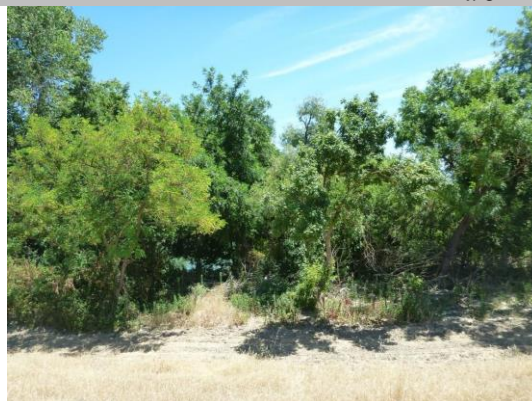
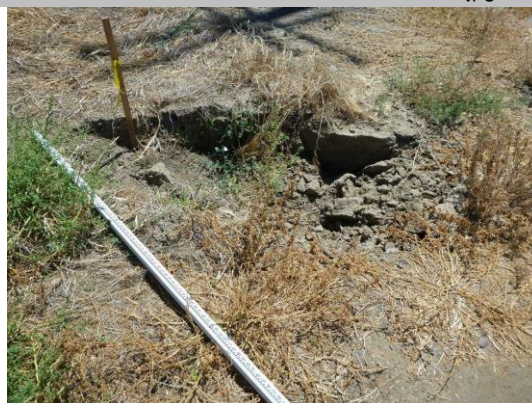
LM Start	47.96	Rating **	A/W	Issue No.	127
LM End	48.06	Issue Type +	Ob	Location *	LS
Category	Earthen Levee			GPS Latitude/Longitude	
				Start	End
Item	Seepage / Sandboils			39.198366 °	39.199645 °
				-121.988567 °	-121.987967 °
DWR ID	DWR_NA0016_01_s_2020_127				
Comment Code					
Inspector Comment					
Planned seepage berm under PL84-99.					
Site ID No:186					
Site Designation:SRWLD-04

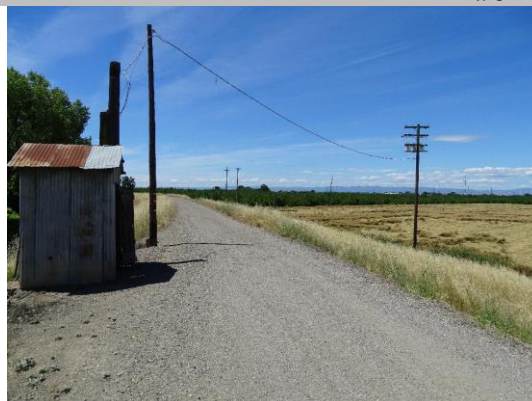
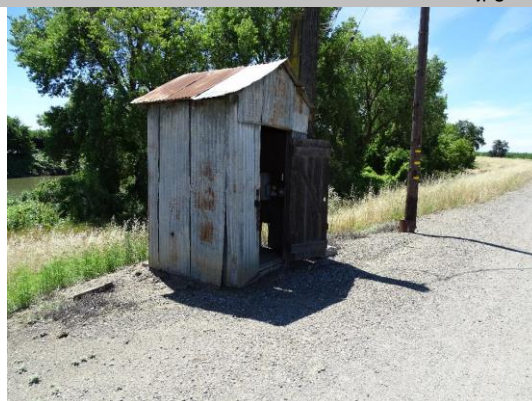
Comment Code						
Inspector Comment						
DS_ID:20299 FS_ID:54232 EP_NO: 9343 Repair Type: Non-Urgent Crossing Status: Found UCIP Comments: 05/23/2019 Crossing looks abandoned. (O.Yakimov - DWR UCIP) FIELD_STRUCT_DESC: 1 of 2: 14-inch steel irrigation pipe through the levee, 17.7 feet below the crown. Switch house on the waterside (WS) shoulder. Slant pump and gate valve on the WS bank. Flow meter inside a 14-inch steel standpipe on the landside (LS) toe. Fresno valve inside a 10-inch steel standpipe on the LS toe. Overhead power line crosses the levee. Poles and anchor on the WS slope. (Automatic Board Order (ABO) issued as Permit No. 9343, 1974 - Emile F. Cribari). [Additional Reference(s): DWR Levee Log, 2006. USACE Sacramento O&M Manual 131, May 1960 (HLM 48.64)]. FS Date: 5/23/2019 11:06:16 AM

Levee crown at crossing

Abandoned switch house on WS sholder

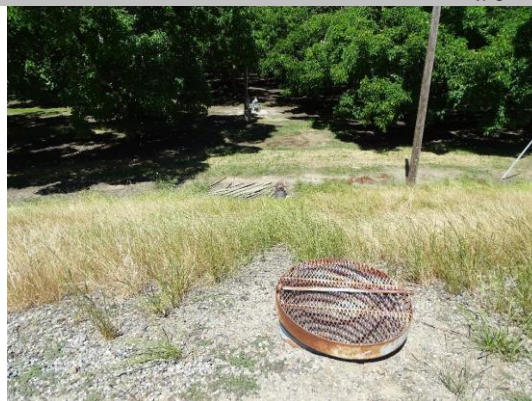
Siphon breaker in 30-inch CMP riser on LS shoulder

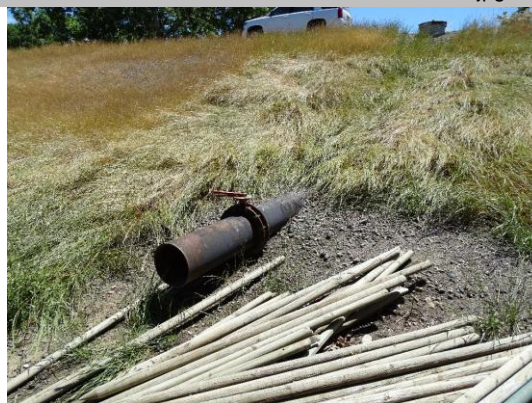
Photo 3 of 3 : UCIP_SP_2020_54233_79979.jpg

LM Start	48.38	Rating **	M	Issue No.	1681 (cont)
LM End	48.38	Issue Type +	En	Location *

Pipe with a butterfly valve at LS toe

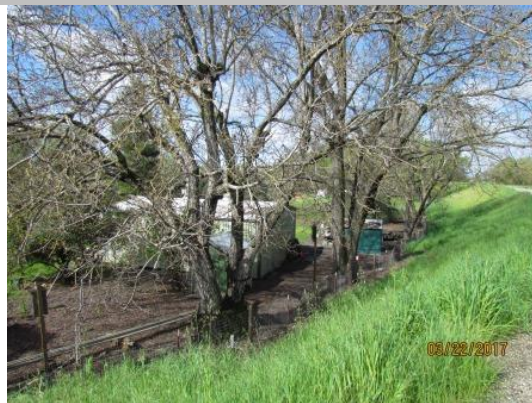
Photo 1 of 1 : SP_2020_NA0016_435_199_20200228_00060.jpg

LM Start	48.58	Rating **	M	Issue No.	199
LM End	49.58	Issue Type +	En	Location *	LS
Category	Earthen Levee			GPS Latitude/Longitude	
				Start	End
Item	Encroachments			39.206495 °	39.213650 °
				-121.984426 °	-121.999883 °
DWR ID	DWR_NA0016_01_s_2017_199				
Comment Code					
FE : Fence					
Inspector Comment					
A fence is along the landside levee toe blocking access.

View of fence along landside levee toe. Spring 2017.

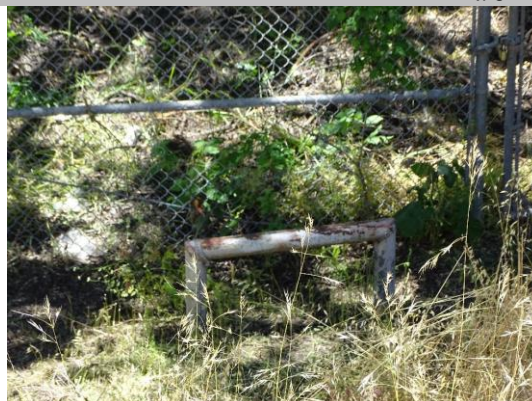
Photo 1 of 3 : UCIP_SP_2020_54235_79981.jpg

LM Start	48.68	Rating **	M	Issue No.	1683
LM End	48.68	Issue Type +	En	Location *	
Category	Supplemental			GPS Latitude/Longitude	
				Start	End
Item	DWR UCIP Field Study			39.207294 °	39.207294 °
				-121.985903 °	-121.985903 °
DWR ID	20352				
Comment Code					
Inspector Comment					
DS_ID:20352 FS_ID:54235 EP_NO: N/A Repair Type: Non-Urgent Crossing Status: Indicator Found UCIP Comments: 05/23/2019 Pipe not found. Confirm pipe removal or abandonment. (O.Yakimov - DWR UCIP) FIELD_STRUCT_DESC: 2 of 2: 7-inch petroleum pipeline of an unknown material through the levee, 2.6 feet below the crown. Metal support for pipe at landside (LS) toe near Shell Oil Co. property edge. Appears to be abandoned. [Additional Reference(s): USACE Sacramento O&M Manual 131, May 1960 (HLM 49.22)]. FS Date: 5/23/2019 11:53:44 AM

Pipe support structure at LS toe

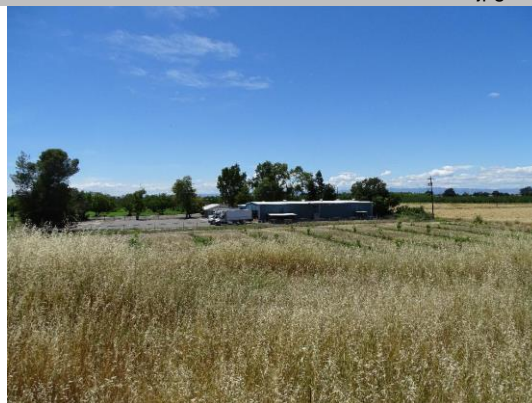
Photo 2 of 3 : UCIP_SP_2020_54235_79982.jpg

Property/yard at LS toe that could have belonged to Shell

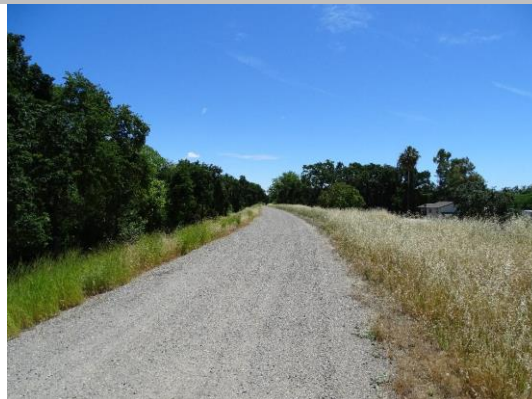
Photo 3 of 3 : UCIP_SP_2020_54235_79983.jpg

Levee crown at crossing

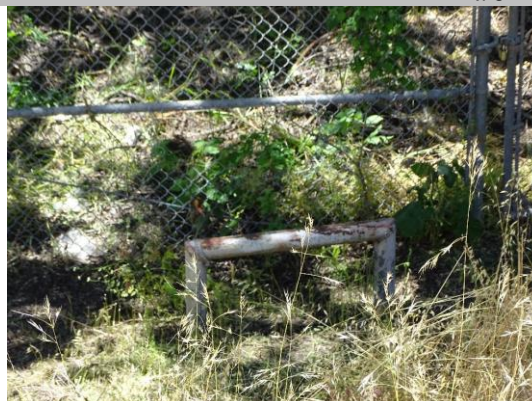
Photo 1 of 3 : UCIP_SP_2020_54236_79984.jpg

DS_ID:20407
 FS_ID:54236
 EP_NO: N/A
 Repair Type: Non-Urgent
 Crossing Status: Indicator Found
 UCIP Comments: 05/23/2019 Pipe not found. Confirm pipe removal or abandonment. (O.Yakimov - DWR UCIP)
 FIELD_STRUCT_DESC: 1 of 2: 7-inch oil pipeline of an unknown material through the levee, 2.6 feet below the crown. Metal support for pipe found at landside (LS) toe near Shell Oil Co. property edge. Appears to be abandoned. [Additional Reference(s): USACE Sacramento O&M Manual 131, May 1960 (HLM 49.22)].
 FS Date: 5/23/2019 2:02:32 PM

Pipe support structure at LS toe

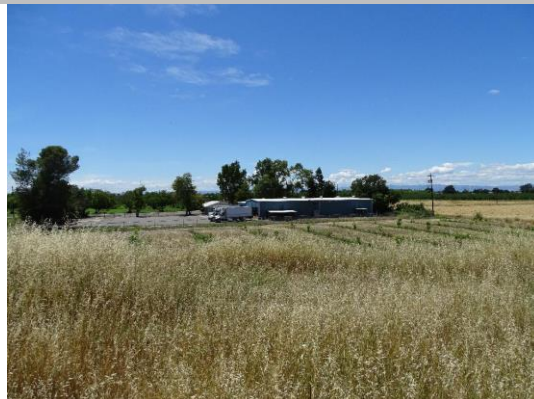
Photo 2 of 3 : UCIP_SP_2020_54236_79985.jpg

Property/yard at LS toe that could have belonged to Shell

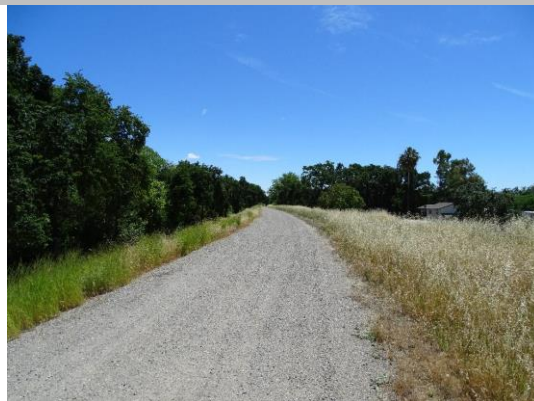
Photo 3 of 3 : UCIP_SP_2020_54236_79986.jpg

Levee crown at crossing

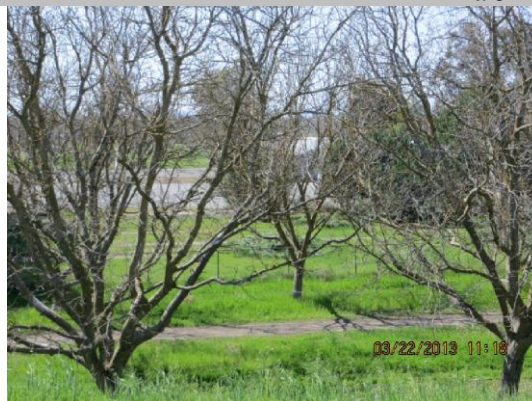
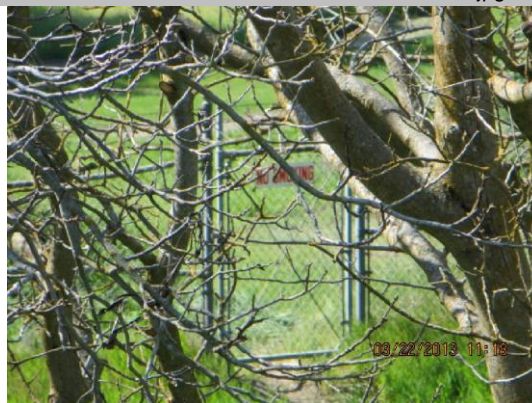
LM Start	48.77	Rating **	M	Issue No.	1685
LM End	48.77	Issue Type +	En	Location *	
Category	Supplemental			GPS Latitude/Longitude	
				Start	End
Item	DWR UCIP Field Study			39.207919 °	39.207919 °
				-121.987343 °	-121.987343 °
DWR ID	20353				
Comment Code					
Inspector Comment					
DS_ID:20353 FS_ID:54237 EP_NO: N/A Repair Type: Non-Urgent Crossing Status: Not Found UCIP Comments: 05/23/2019 Crossing not found (O.Yakimov - DWR UCIP)03/22/2013 All four pipes appear to have been removed. FIELD_STRUCT_DESC: 1 of 4: 7-inch petroleum pipeline of an unknown material through the levee, 2.6 feet below the crown. Union Oil Co. dock. (Permit No. 1499, 1950 - Union Oil Company). [Additional Reference(s): USACE Sacramento O&M Manual 131, May 1960 (HLM 49.33)]. FS Date: 5/23/2019 2:37:16 PM

Shell yard off LS toe.

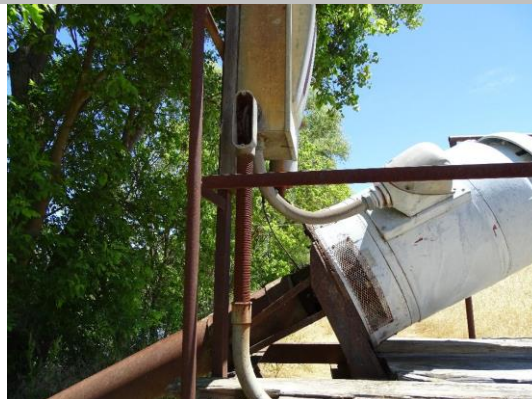
Photo 2 of 3 : UCIP_SP_2020_54244_79989.jpg

Conduit at slant pump

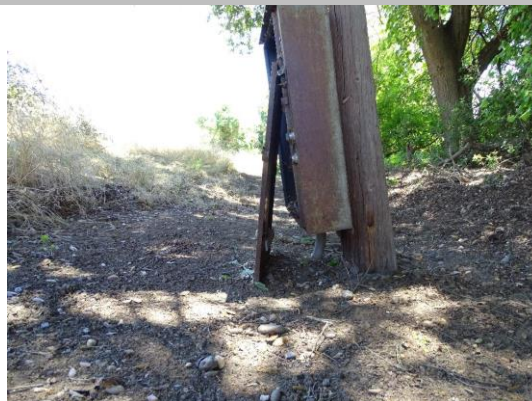
Photo 3 of 3 : UCIP_SP_2020_54244_79996.jpg

Conduit enters levee at LS toe

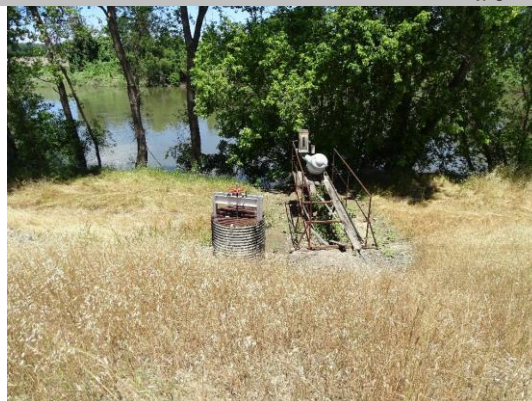
Photo 1 of 3 : UCIP_SP_2020_54245_79992.jpg

Comment Code					
Inspector Comment					
DS_ID:20301 FS_ID:54245 EP_NO: 9334 Repair Type: Non-Urgent Crossing Status: Found UCIP Comments: 05/23/2019 Pipe angles through the levee. Concrete box on LS found 30 feet upstream from pump on WS berm. No issues recorded during inspection (O.Yakimov - DWR UCIP) FIELD_STRUCT_DESC: 2 of 2: 36-inch corrugated metal irrigation pipe through the levee, 18.5 feet below the crown. Vertical pump unit on piling structure in the stream. Concrete pipe collar on the waterside (WS) end. Slide gate inside a 48-inch corrugated metal riser unit on the WS slope. Two corrugated metal cutoff walls. Timber walkway on the WS. Flap gate inside a concrete box on the landside (LS). Meter pole at the LS toe. (Automatic Board Order (ABO) issued as Permit No. 9334, 1974 - Owner Unknown). [Additional Reference(s): DWR Levee Log, 2006]. FS Date: 5/23/2019 2:28:12 PM

Pump and CMP riser on WS berm

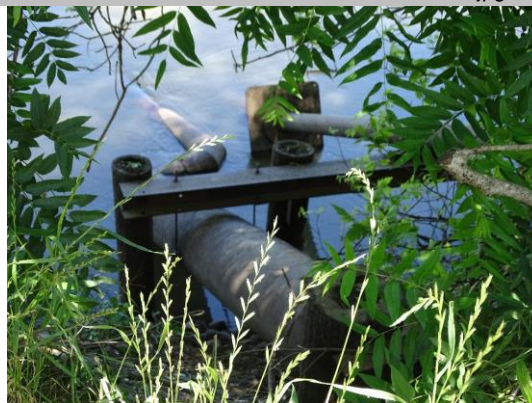
Photo 2 of 3 : UCIP_SP_2020_54245_79994.jpg

Pipes at riverbank

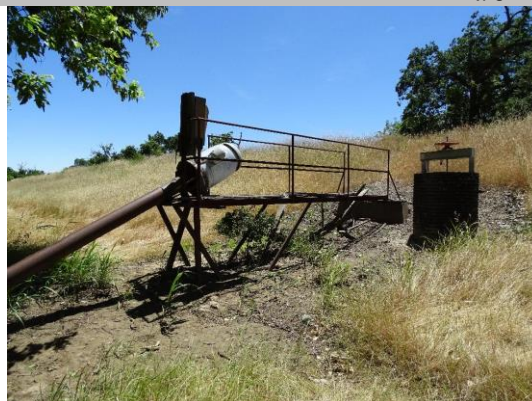
Photo 3 of 3 : UCIP_SP_2020_54245_79995.jpg

Pump with disrupted timber walkway and slide gate inside of CMP riser on WS berm

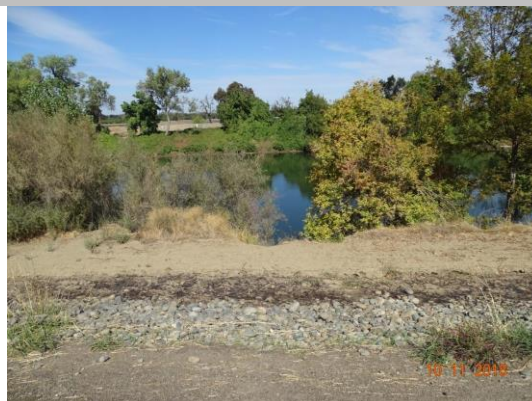
Photo 1 of 1 : SP_2020_NA0016_435_113_20200228_00042.jpg

LM Start	49.42	Rating **	A/W	Issue No.	113
LM End	49.42	Issue Type +	Ma	Location *	WS
Category	Earthen Levee			GPS Latitude/Longitude	
				Start	End
Item	Erosion / Bank Caving			39.213303 °	39.213303 °
				-121.996915 °	-121.996915 °
DWR ID	DWR_NA0016_01_f_2018_113				
Comment Code					
E1 : Note and monitor erosion site.					
Inspector Comment					
Runoff erosion is located on the waterside berm. Recommend monitoring.

View of erosion on the waterside berm. Fall 2018.

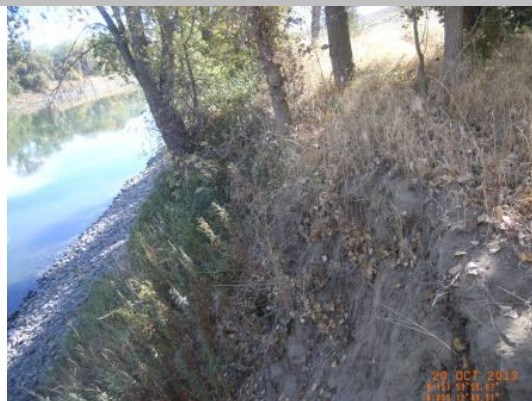
Photo 1 of 1 : SP_2020_NA0016_435_105_20200228_00034.jpg

LM Start	49.46	Rating **	A/W	Issue No.	105
LM End	49.57	Issue Type +	Ma	Location *	WS
Category	Supplemental			GPS Latitude/Longitude	
				Start	End
Item	2017 USACE Erosion Survey			39.213608 °	39.213869 °
				-121.997543 °	-121.999641 °
DWR ID	DWR_NA0016_01_f_2018_105				
Comment Code					
Inspector Comment					
2017 Site ID: SAC 143.5 R					
Status: Eroding					
2017 Field Notes: New erosion along lower slope.					
Site History: 2011 - Multiple scallops, one tree pop out. Old cobble site starting to unravel at midbank. 2012 - Mid bank slumping continues to worsen but cobble at the toe appears stable.
